Flood Investigation Report

Locations: Various across Bedford Borough

Flood Event: October 2022

Date of Report: June 2025

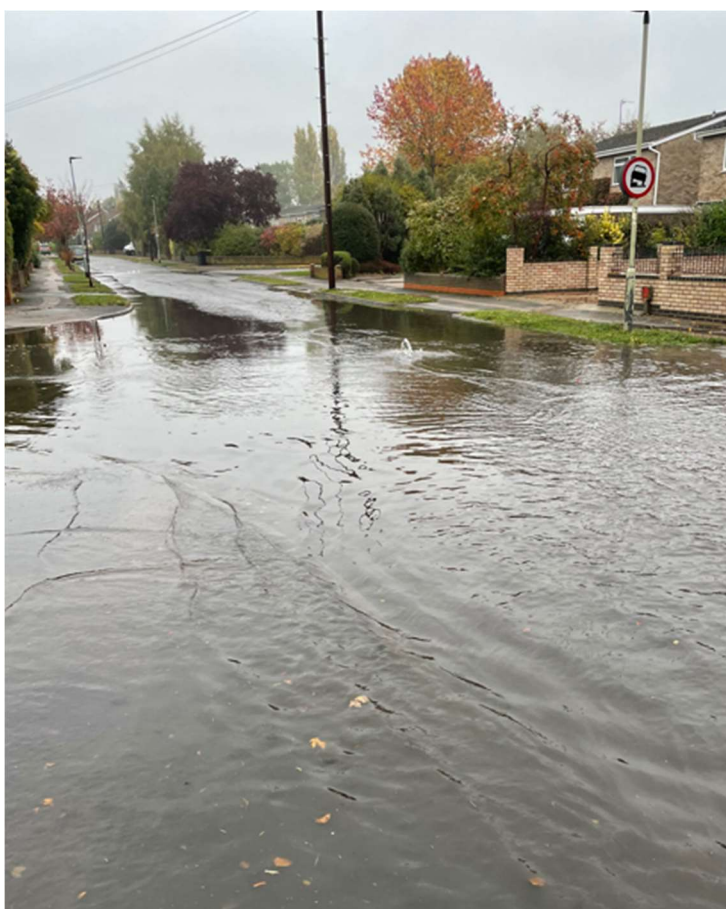
Figure 2.0 Surface water flooding in Brickhill

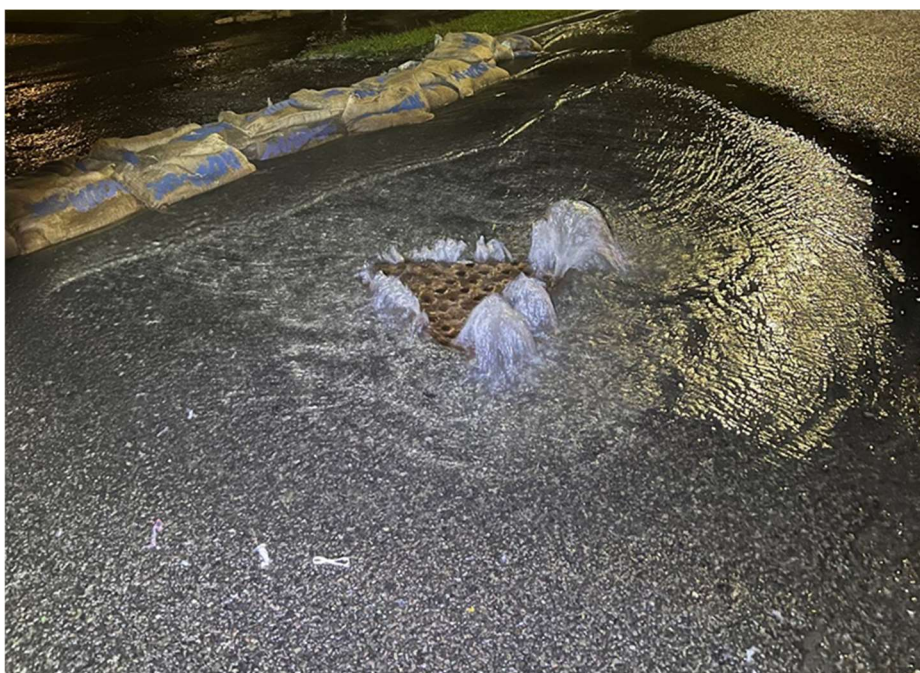
Figure 3.0 Anglian Waters Foul system surcharging
