The village of Bolnhurst suffered flooding in December 2020. Under the Flood and Water Management Act 2010, Bedford Borough Council as the Lead Local Flood Authority (LLFA) has the duty to investigate the flood event. The scope of this flood investigation is to identify the source, cause and impact of flooding from available information; identify actions completed by relevant Risk Management Authorities (RMAs) in response to the flood event; and consider actions to better understand and manage the risk of flooding in the affected area.

SOURCE OF FLOODING: Surface Water

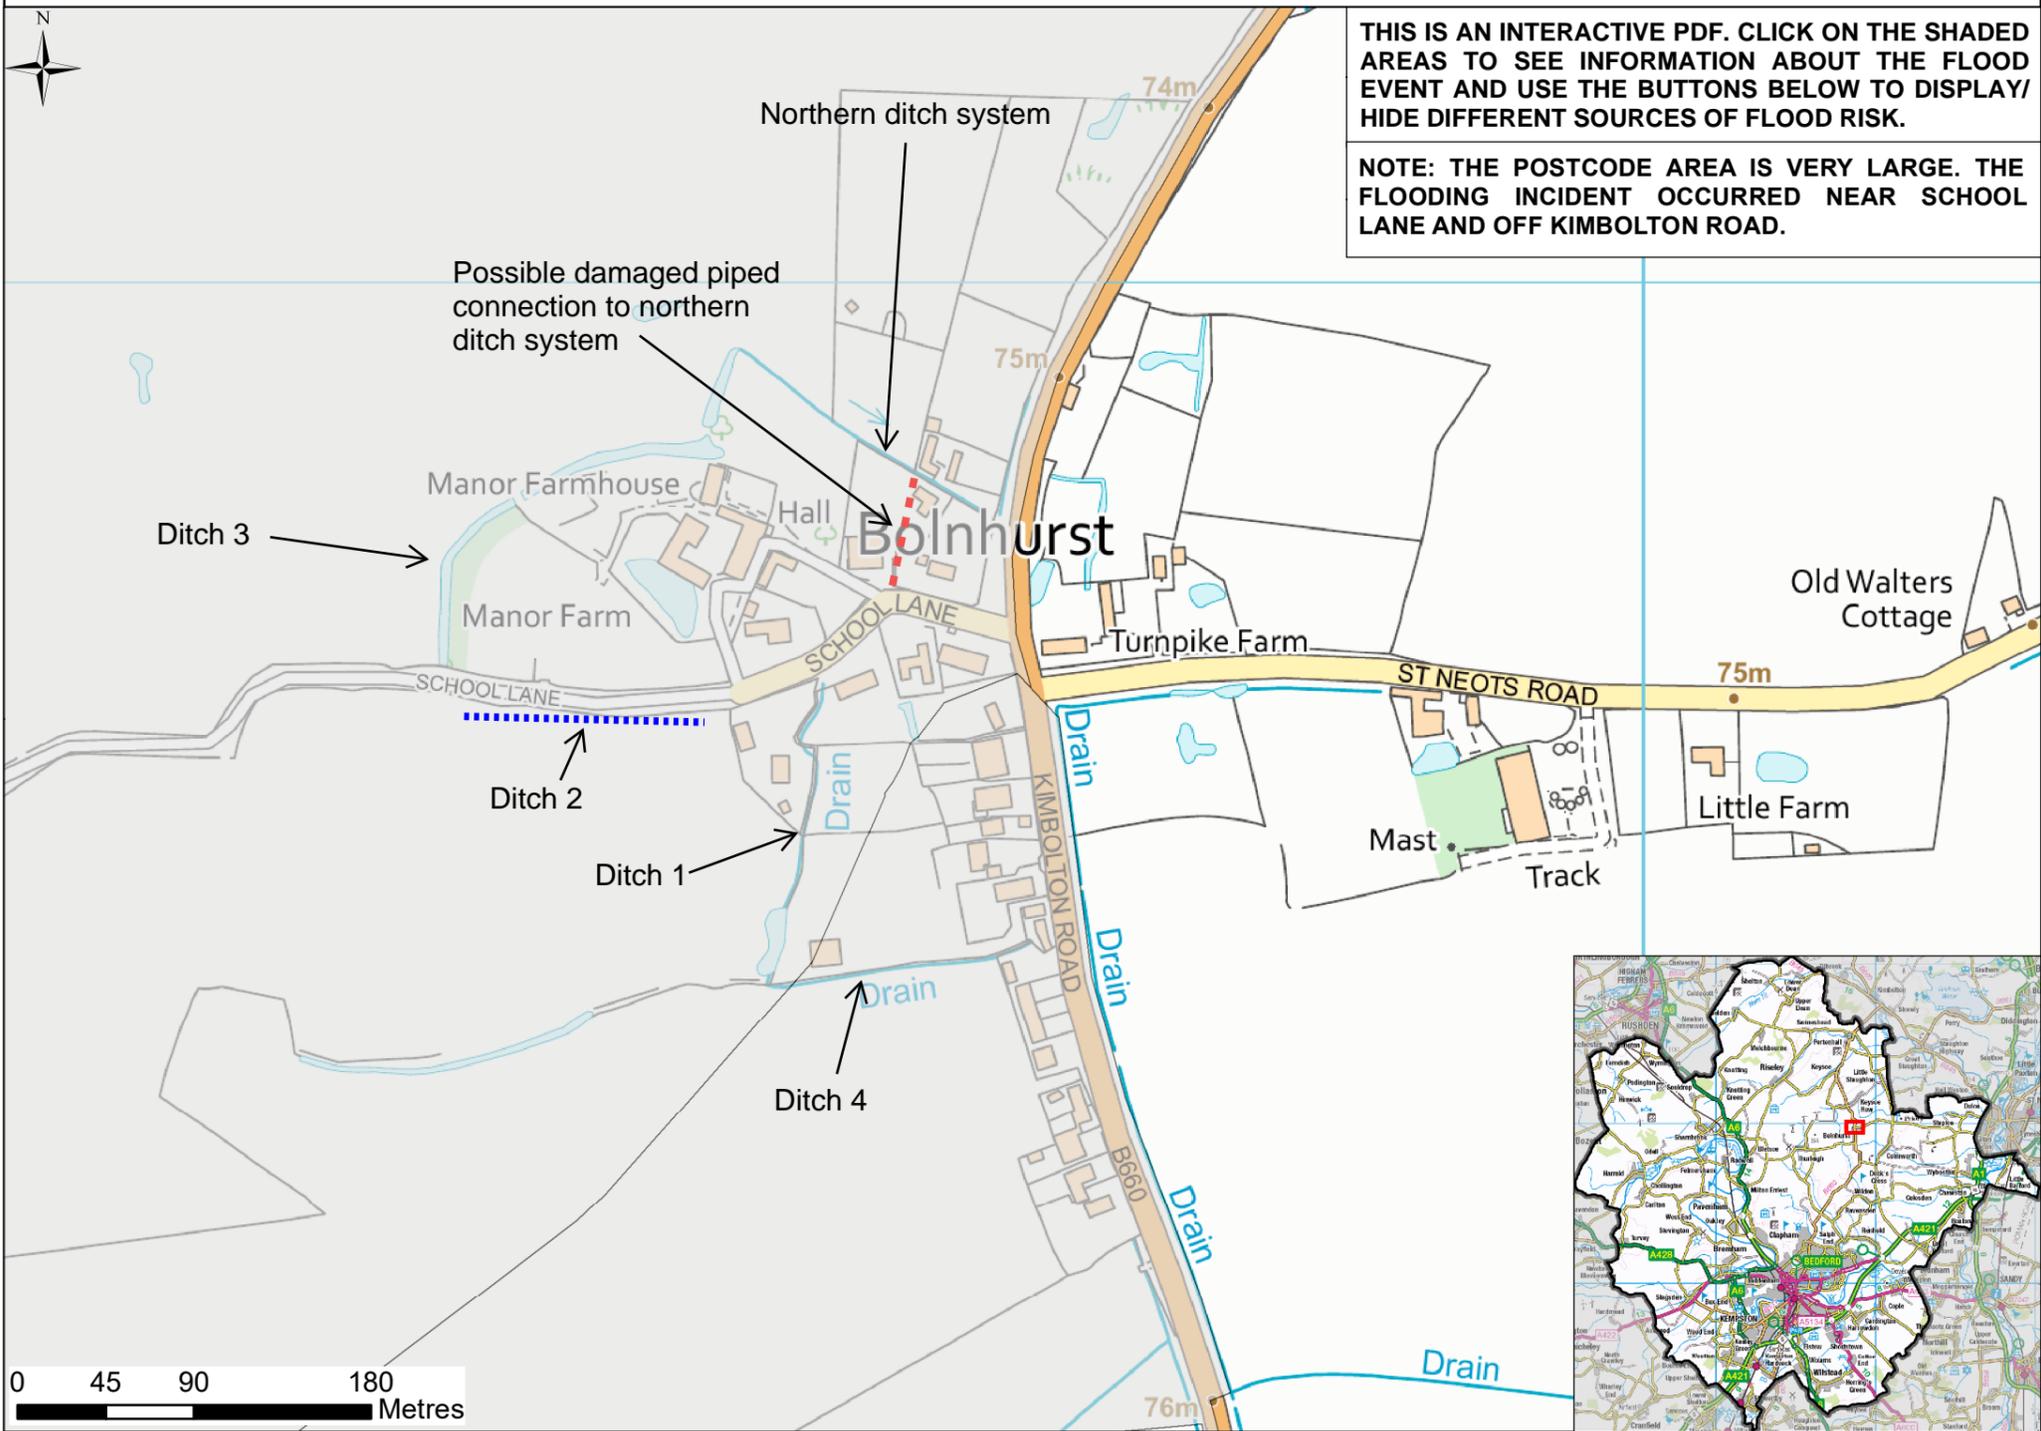
A community building off School Lane experienced internal flooding following the heavy rainfall in the area between December 23rd and the early hours of December 24th, causing extensive damage throughout. School Lane was reported to be impassable due to the floodwater. The reported flood mechanism is consistent with the Environment Agency Flood Risk from Surface Water Mapping¹, which shows that water is predicted to flow toward School Lane from two ditches (ditch 1 and 2 on the map). The heavy rainfall resulted in overland flows across the fields and is thought to have overwhelmed the capacity of the ditches, overtopping onto School Lane and the community building.

Ditch 2 (see map annotation) is understood to fall from west to east. However, it is understood there is pipe beneath School Lane which connects ditch 2 to ditch 3 to the north and could provide an alternative outfall. In addition, it is thought likely that the flooding at the community building was exacerbated due to a piped connection between School Lane and the ditch system to the north (see map annotation) having been damaged, causing water to back up.

A second property (residential) approximately 200m further south off Kimbolton Road flooded internally at 1am on December 24th to approximately 100mm depth throughout the ground floor, and more extensive depths in the garage. It was reported that the flooding occurred from flood water overtopping ditch 4 (see map annotation), which is reported to have been in need of maintenance. The reported flood mechanism is consistent with the Environment Agency Flood Risk from Surface Water mapping, which shows a flow route from the ditch causing water to pond at the property. It is not clear if this ditch has a formal outfall or infiltrates to ground.

December 2020 was a very wet month with an average rainfall of 108mm across East Anglia, which is 95% higher than the December average². The three months leading up to December also saw higher than average rainfall such that by December 23rd the ground was already saturated. This, combined with the rainfall recorded during the dates in question, meant that surface water was less able to infiltrate into the ground and more likely to run off into ditches and form overland flood flow routes. The general direction of surface water flow in Bolnhurst is thought to be northwards, via roadside ditches to join the Duloe Brook. There are, however, a number of ditches surrounding the village appear to be isolated with no obvious discharge location. In conclusion, it is thought that the flooding in Bolnhurst occurred due to a combination of saturated ground, high rainfall, and blocked ditches/drainage.

Timescale	Action	Responsible Party
Complete	Investigate highway drainage in the area and clear any blockages. A blocked gully on School Lane opposite the old School House was cleared in February 2021.	Bedford Highways
Short term (action started)	Liaise with the landowner to regrade the ditch immediately south of School Lane (ditch 2 on map annotation) and investigate the pipe connection to the north ditch system. Liaise with landowners of ditch 3 to understand that the ditch is running at full capacity and free from blockages.	Lead Local Flood Authority / Riparian Owner
Short term (action started)	Investigate the potential to divert the surface water flow route from School Lane into a soakaway. The soil characteristics are currently being assessed.	Bedford Highways
Short term (1-6 months)	Liaise with the landowner to ensure the ditch leading to Kimbolton Road (ditch 4 on map annotation) is maintained, agreeing a suitable inspection and maintenance regime as necessary. Investigate the discharge of this ditch and consider improvements as appropriate.	Lead Local Flood Authority / Riparian Owner

Medium term (6-12 months)	Investigate the condition and levels of the potential damaged pipe connection between School Lane and the ditch system to the north to understand if there would be any benefit in re-instating it.	Bedford Highways / Landowner
Medium term (6-12 months)	Investigate the benefit of resizing the ditch to the south of School Lane to maximise the amount of water held upstream. Liaise with landowners to discuss findings and agree next steps.	Lead Local Flood Authority

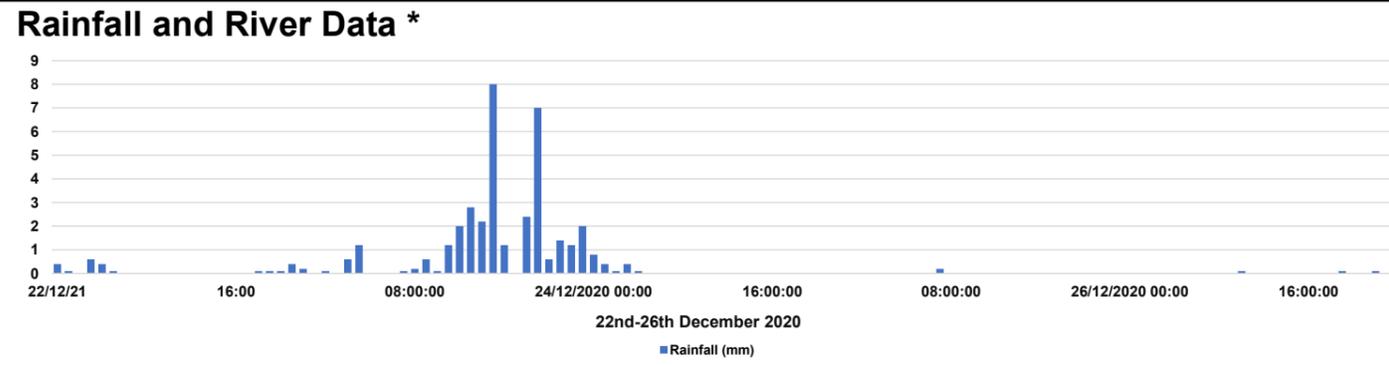
Rainfall and River Gauges

The graph identifies that the main rainfall event at the nearest rainfall gauge to Bolnhurst occurred between 08:00 on December 23rd and 04:00 on December 24th. The total rainfall volume is recorded as 34.7mm with a peak rainfall intensity of 8mm/hour. This single event saw more than half of the 55mm of rainfall which is expected for the whole month of December on average. There are no Main Rivers or significant watercourses in the vicinity of Bolnhurst. The flood mechanism in Bolnhurst is therefore not expected to be related to river levels.
