The village of Odell suffered flooding in December 2020. Under the Flood and Water Management Act 2010, Bedford Borough Council as the Lead Local Flood Authority (LLFA) has the duty to investigate the flood event. The scope of this flood investigation is to identify the source, cause and impact of flooding from available information; identify actions completed by relevant Risk Management Authorities (RMAs) in response to the flood event; and consider actions to better understand and manage the risk of flooding in the affected area.

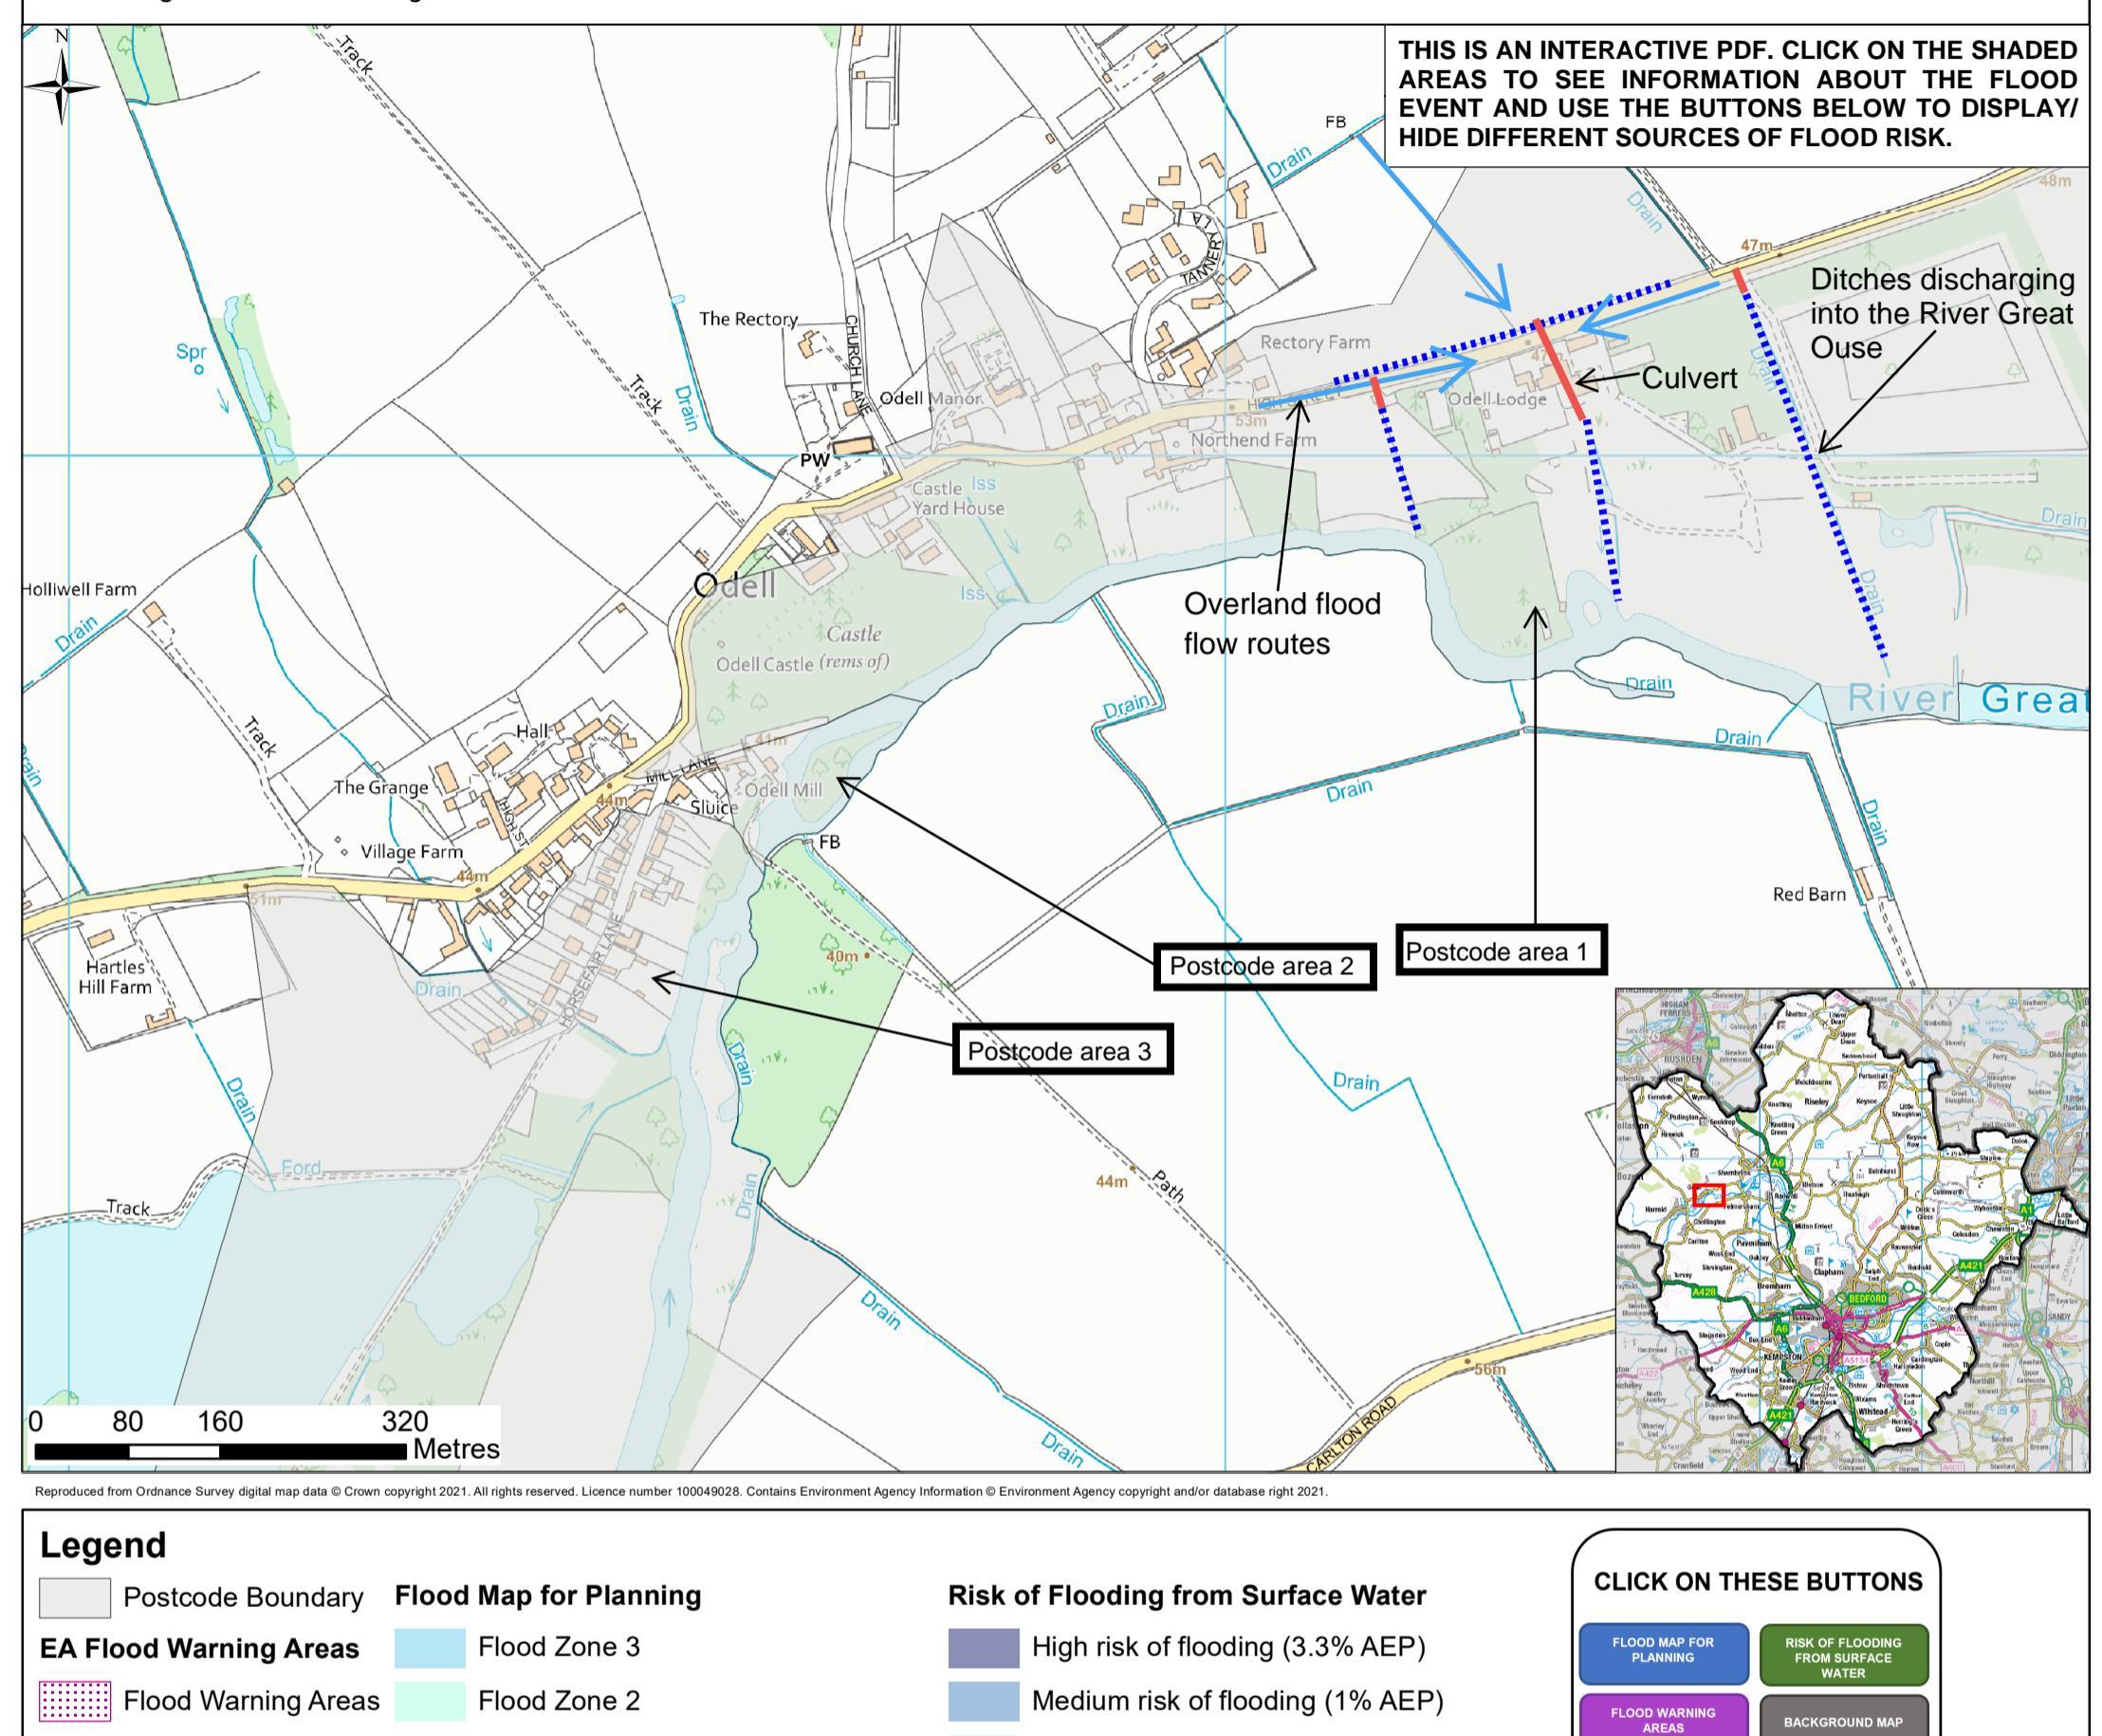
One property located off High Street reported internal flooding on December 23rd from the fields and ditch to the north of the property and from flood flow routes along the road. The resident attempted to dig ditches around the property to reduce water ingress, however, water did encroach within the property up to a depth of approximately 150mm.

The reported flood mechanism is partially consistent the Environment Agency Flood Risk from Surface Water mapping¹, which identifies a flood flow route through the fields to the north of High Street. The flow route from the fields flows into a ditch on the northern side of High Street (see map annotation). The heavy rainfall also caused overland flood flow routes on High Street, which were conveyed along the road towards a topographic low point (see map annotation). The ditch is culverted beneath the road near the low point before becoming an open-channel ditch further south and discharging into the River Great Ouse. There are two additional drainage ditches (see map annotation) which convey runoff from High Street and areas to the north into the River Great Ouse. It was reported to Bedford Highways in mid-January 2021 that two culverts beneath High Street were in need of maintenance, however, the condition of the highway drainage or culverts prior to the flood event is unknown. Any build-up of debris or blockages would have exacerbated the flooding experienced.

In conclusion, December 2020 was a very wet month with an average rainfall of 108mm across East Anglia, which is 95% higher than the December average². The three months leading up to December also saw higher than average rainfall such that by December 23rd the ground was already saturated. This, combined with the rainfall recorded during the dates in question, meant that surface water was less able to infiltrate into the ground and more likely to run off into ditches and form overland flood flow routes. It is thought that the heavy rainfall overwhelmed the capacity of the local drainage/ditch network, causing water to overtop and contribute to the flooding experienced at the property.

Timescale	Action	Responsible Party
Complete	Clear debris build-up and blockages in High Street culverts. Two culverts were cleared in March 2021.	Bedford Highways
Complete	Increase capacity and/or maintain highway drainage along High Street. Following the flood event, grips were dug either side of High Street to facilitate water draining away from the road into the adjacent ditches.	Bedford Highways
Complete	Increase capacity and/or maintain the ditches along High Street. This was completed by the resident following the flood event.	Landowner / Lead Local Flood Authority
Complete	Set up a community flood group. The flood group should enable access to the flood kits, flood action plans, and information about flood warnings/alerts and Property Flood Resilience (PFR).	Lead Local Flood Authority
Ongoing	Continued engagement with and support of the community flood group to enable preparedness in the event of a future flood.	Lead Local Flood Authority

Short-term (1-6 months)	Set an appropriate inspection and maintenance regime for the highway grips along High Street, such that they are maintained appropriately ahead of severe rainfall events.	Bedford Highways
Medium-term (6-12 months)	Liaise with landowners to identify suitable land management techniques for the fields to the north of High Street, to reduce the amount of water which flows into the drainage ditches and highway grips.	Lead Local Food Authority
ORIGINATED: 1 CHECKED/VER	Nora Balboni CEng C.WEM MCIWEM, Senior Engineer, 14/07/2021 RIFIED: Matt Tandy C.WEM MCIWEM MInstLM, Principal Engineer, 16/07/2021	AECOM

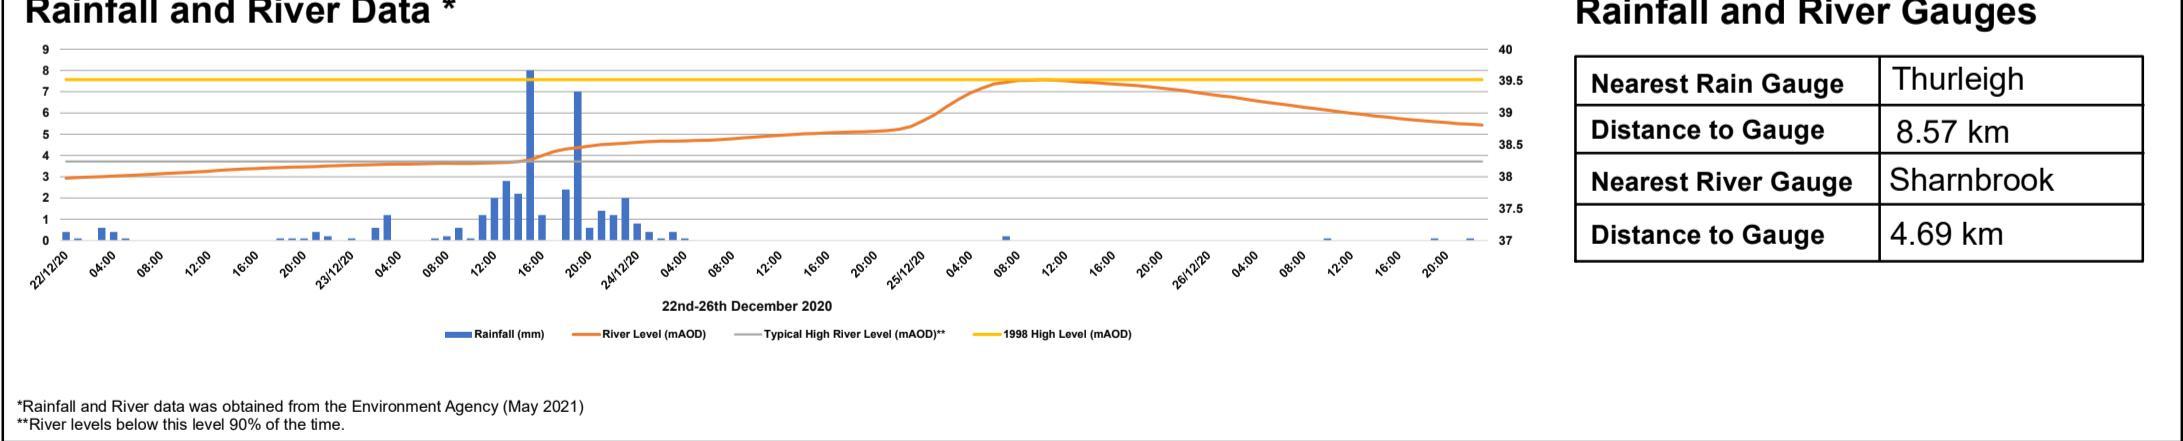
Rainfall and River Data *

The graph identifies that the main rainfall event at the nearest rainfall gauge to Odell occurred between 08:00 on December 23rd and 04:00 on December 24th. The total rainfall volume is recorded as 34.7mm with a peak rainfall intensity of 8mm/hour. This single event saw more than half of the 55mm of rainfall which is expected for the whole month of December on average.

The graph shows that the river levels in the Great Ouse were elevated above the 'typical high river level' from 15:00 on December 23rd and stayed above this level until beyond December 26th. The 'typical high river level' at the nearest gauge station is identified as 38.2m Above Ordnance Datum (AOD). River levels above this are only expected to be recorded 5% of the time. For context, the 1998 peak flood level is included, which was recorded as 39.5m AOD, and the graph shows that the December 2020 river levels reached the 1998 level at 07:00 on December 25th.
