Flood Investigation Report

Locations: Various across Bedford Borough

Flood Event: December 2020

Date of Report: October 2021

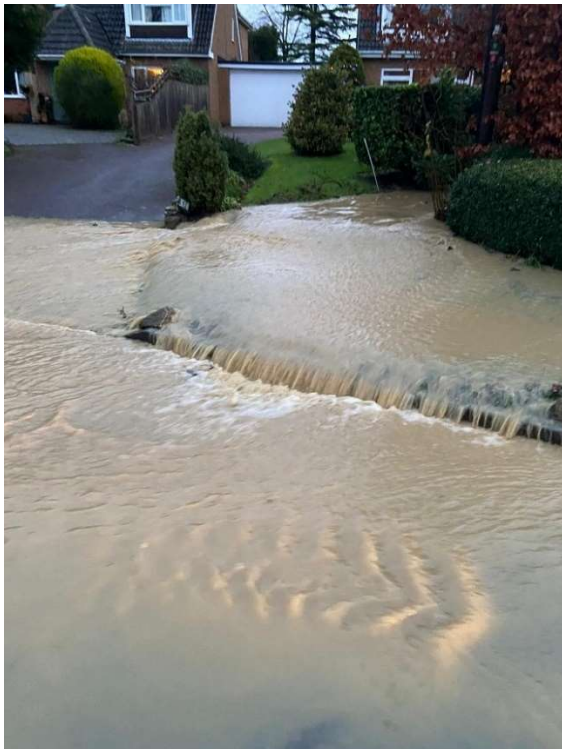
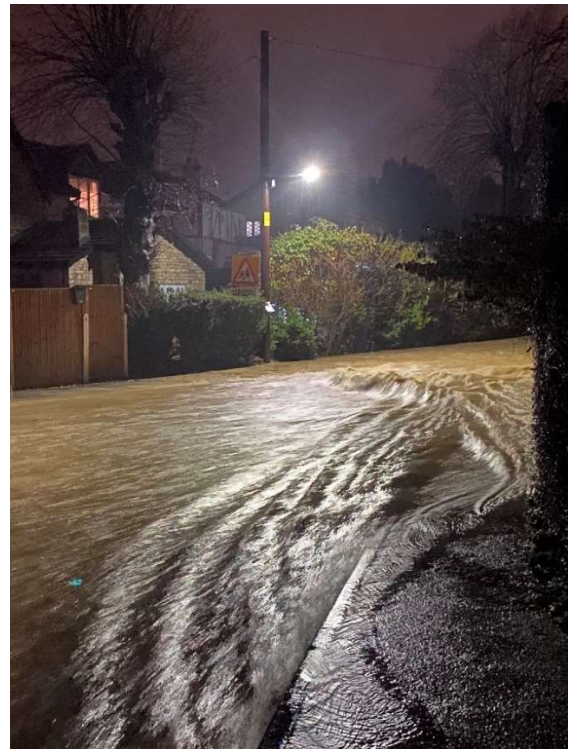
Figure 2.0 Pavenham Road, Felmersham (left) and Rushden Road Wymington (right)

Figures 2.0 to 4.0 below highlight some of the impact caused by the flooding across the Borough from both surface water and fluvial flooding.

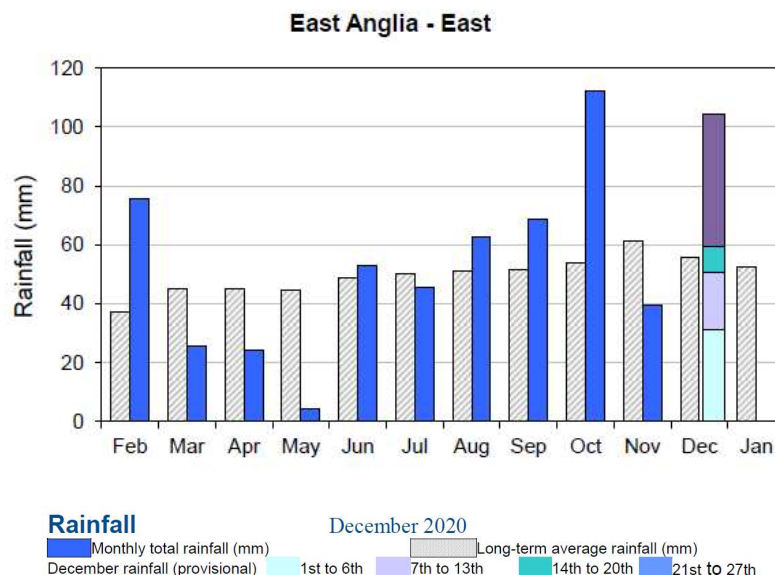
Figure 6.0 Monthly rainfall compared to long term average

The three months preceding December also received a high amount of rainfall, calculated as 154% of the Long-Term Average (figure 6.0). This meant that by December 23rd, the ground was already saturated therefore rainfall was less able to infiltrate and more likely to form overland flow routes and run off into the surrounding drainage systems and watercourses.
