Flood Investigation Report

Locations: Various locations across the Borough

Flood Event: September 2024

Date of Report: March 2026

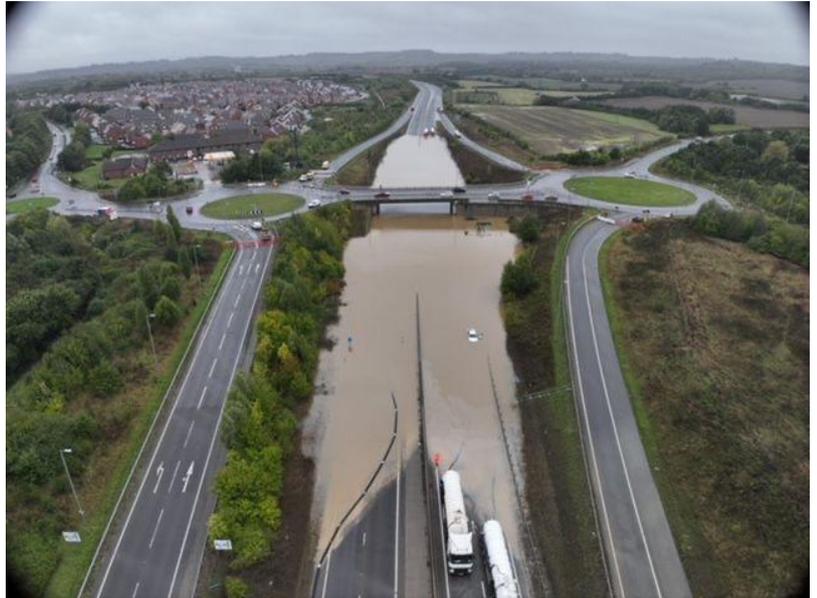
The Following Borough Highway roads were also flooded and closed:

- A428 Turvey
- High Street, Great Barford
- Green Lane, Stewartby
- Harrold Bridge
- Oakley Bridge
- Felmersham Bridge
- Radwell Bridge
- High Street, Clapham
- Water Lane, Kempston
- Lovell Road,
- A6 Sharnbrook
- A6 Paula Radcliffe North Bound Closed
- A6 Paula Radcliffe South Bound Closed

Many other roads in the north of the Borough were completely impassible. Several schools shut on the 26th of September as a result of the rainfall the previous day and high river levels, making travel routes around the north of the Borough challenging.

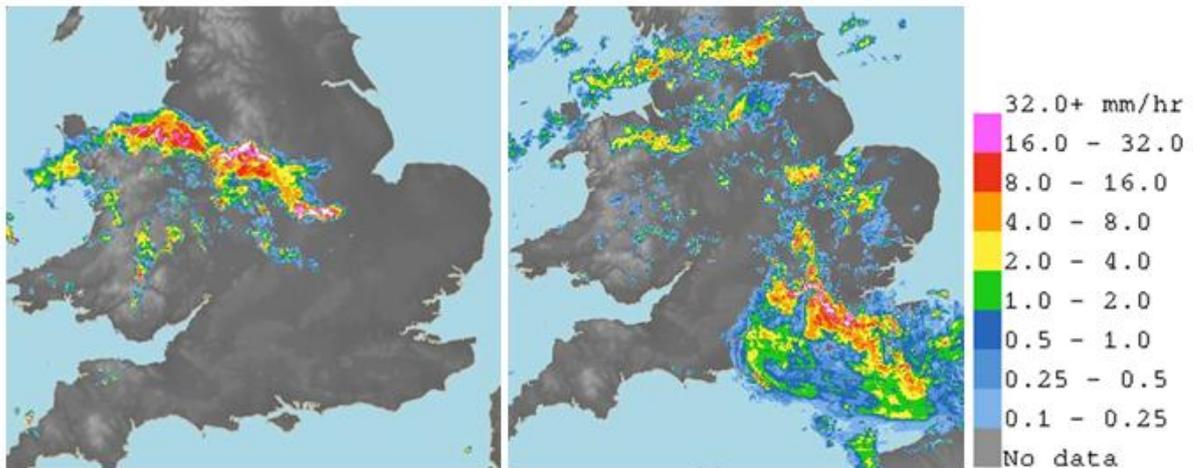
Figure 2.0 Rain-radar images 21st and 23rd September 2024.

The rain-radar images (Figure 2.0) left on the 21st of September and right the 23rd September provide an indication of the intensity of rainfall experienced during this event.

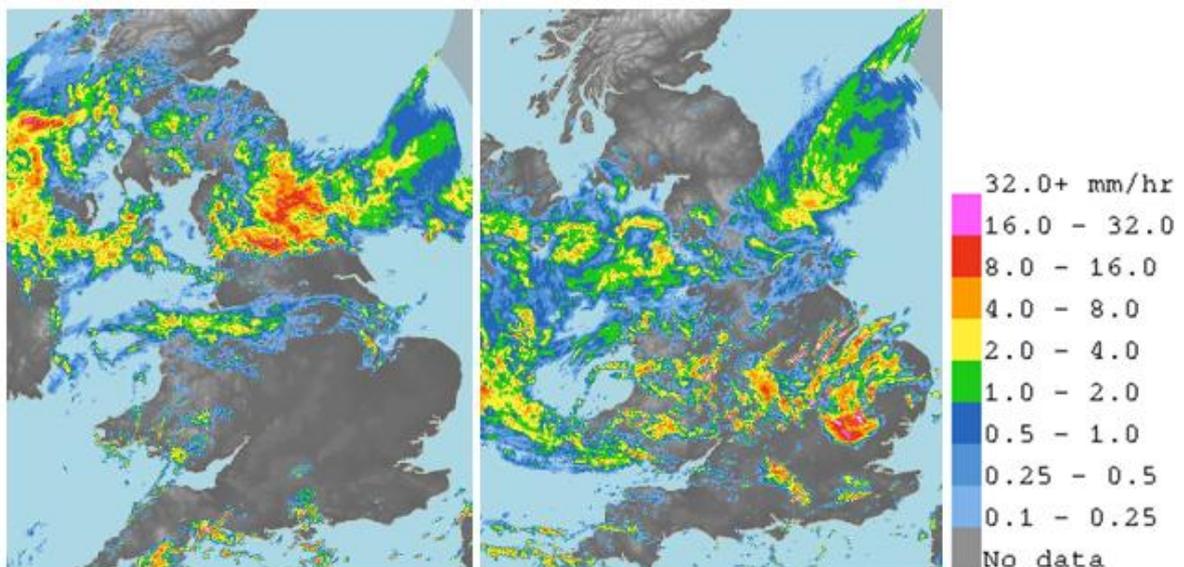
Figure 3.0 Rain-radar images 26.09.24

The rain-radar images on the 26th September (figure 3.0) at 09:00 on the left and 16:30 on the right show the heavy rainfall associated with the next area of low pressure, with bands of torrential downpours spreading across much of central England and Wales.

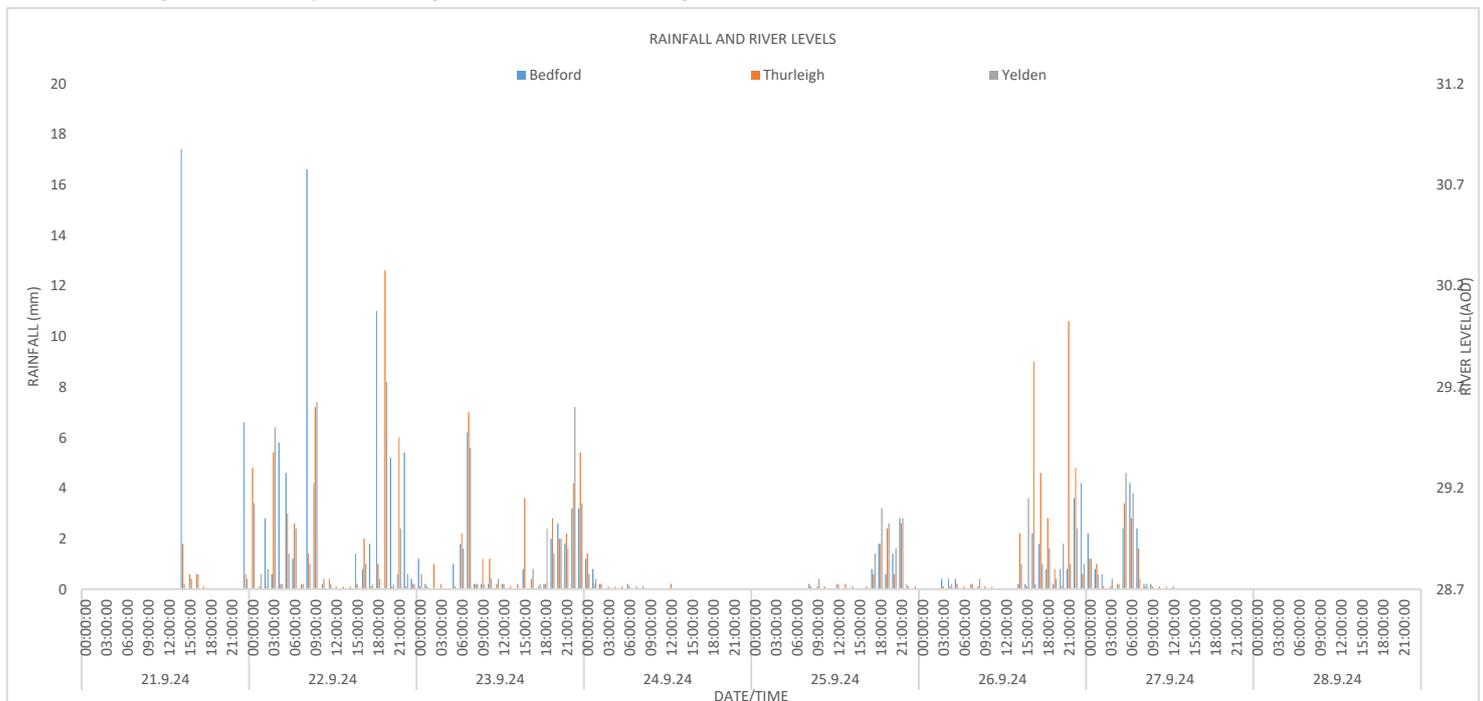
Figure 4.0 Hourly Rainfall figures across the Borough from 21st – 28th September 2024

Figure 4.0 identifies the hourly rainfall amounts recorded during the week of 21st – 28th September 2024 at rain gauges in Bedford, Yelden and Thurleigh for comparison. It

was evident the intensity of rainfall varied significantly and was evident by the sporadic nature of property flooding due to pluvial flooding. On the 22nd of September 62.4 mm of rainfall was recorded on the Bedford gauge on top of 24mm the previous day. This unprecedented rainfall amount caused local drainage systems to quickly become overwhelmed, causing overland flows towards at risk properties.

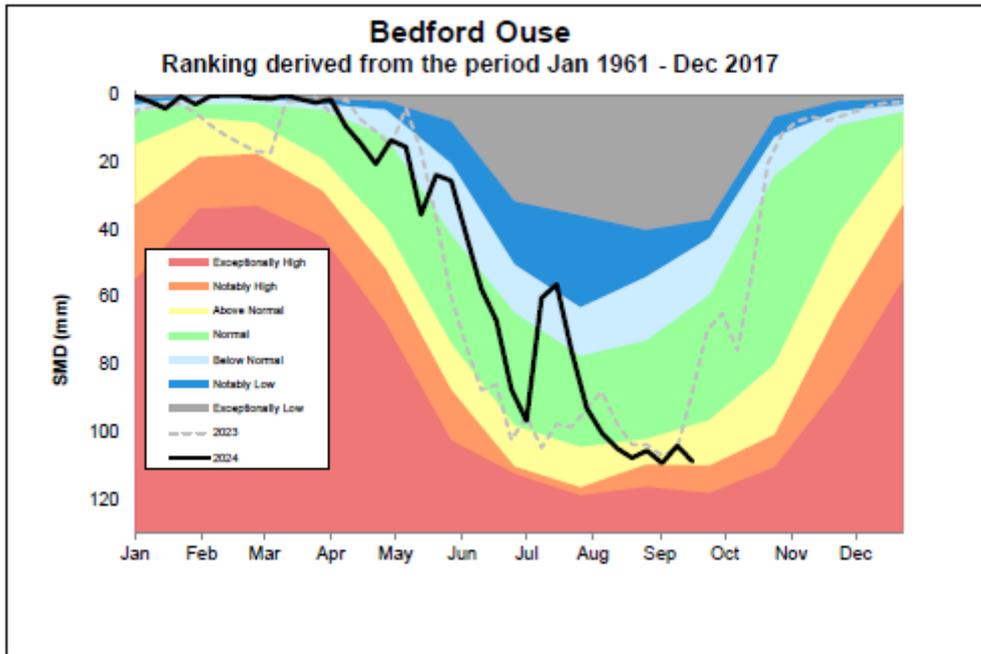
Figure 5.0 SMD levels from week ending 17th September 2024

The soil moisture deficit (SMD) ground saturation leading up to the week commencing the 21st of September was above normal for the time of year at 110mm, as shown on figure 5.0. However following the rainfall that week, the catchment soon became saturated, reading SMD levels at 7mm the week after the event. The huge peak in ground saturation can be evidenced in figure 6.0 with levels noticeably low for the time of year. The rainfall was high enough that despite most of the month prior being dry, the final week made September 2024 the wettest on record.

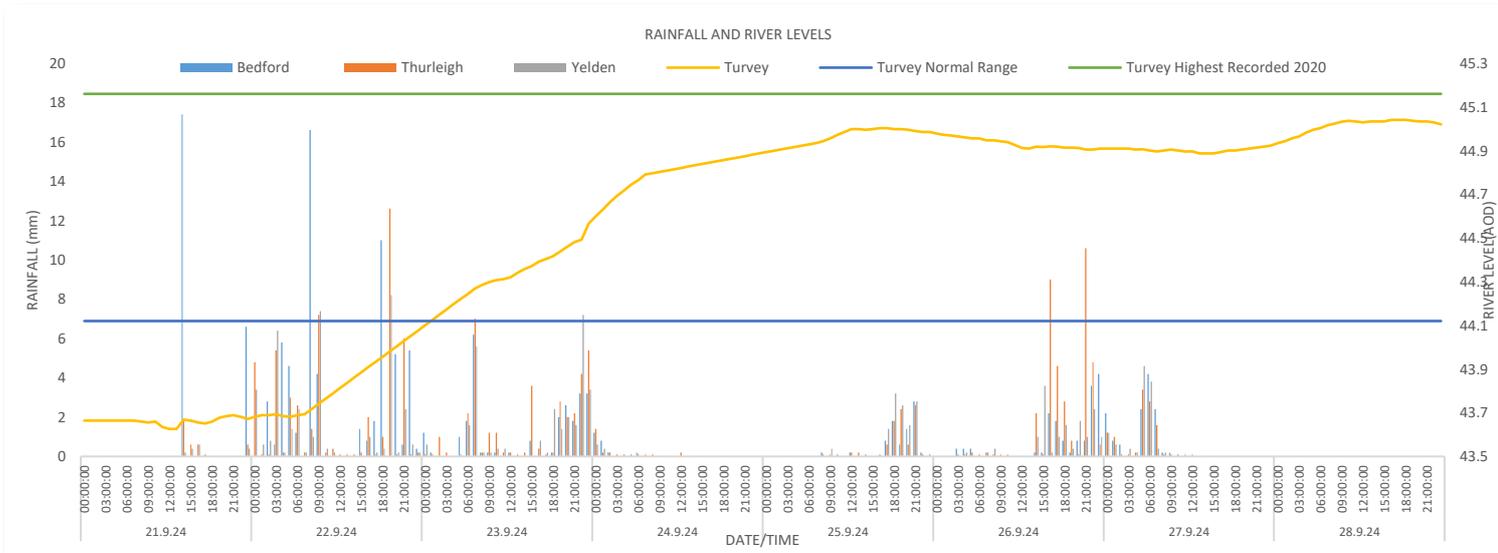
Figure 7.0 River levels at Turvey from 21st – 28th September 2024

the first rainfall event. So ultimately had capacity to hold the huge rainfall amounts received during that week. At the Turvey gauge (Figure 7.0) levels rose above normal level on 23rd and continued to rise until the first peak passed through on the 25th of September reaching 45 AOD. Levels dropped slightly then rose again peaking 3 days later at a slightly higher level of 45.04 AOD. This pattern was mirrored downstream with the peak coming through Bromham and Bedford on the 26th of September. The second peak following around 3 days later again at slightly higher levels, but still below that from the December 2020 flood event.

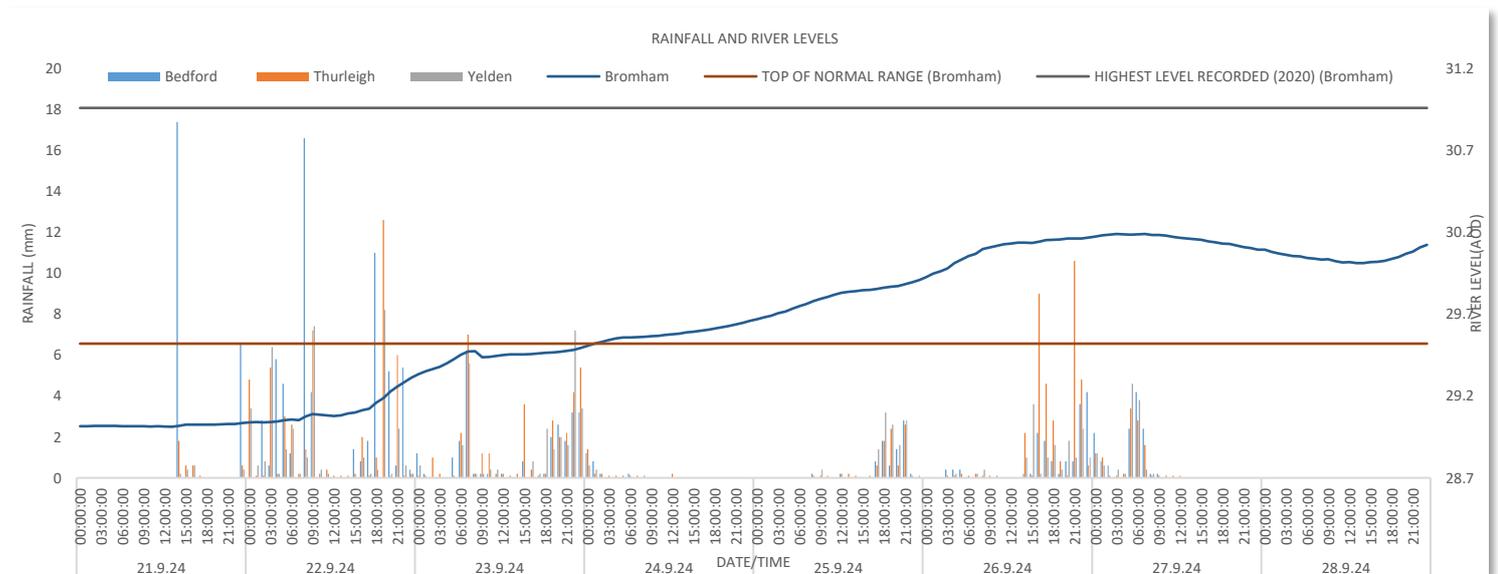
Figure 8.0 River levels at Bromham from 21st – 28th September 2024

The River Great Ouse reacted as a result of the rainfall across the catchment and led to high river levels coming down the Ouse. Two main peaks affected residential and commercial properties that are at risk of fluvial flooding. Figure 7.0 – 9.0 highlights the highest levels coming down the River Great Ouse at Turvey, Bromham and Bedford. Flood Alerts and Warnings were issued by the Environment Agency; however, levels did not exceed those highest ever recorded, apart from one location at Eaton Socon. This was predominately due to the river levels being below the normal range prior to
