Flood Investigation Report

Locations: Various across Bedford Borough

Flood Event: October 2022

Date of Report: June 2025

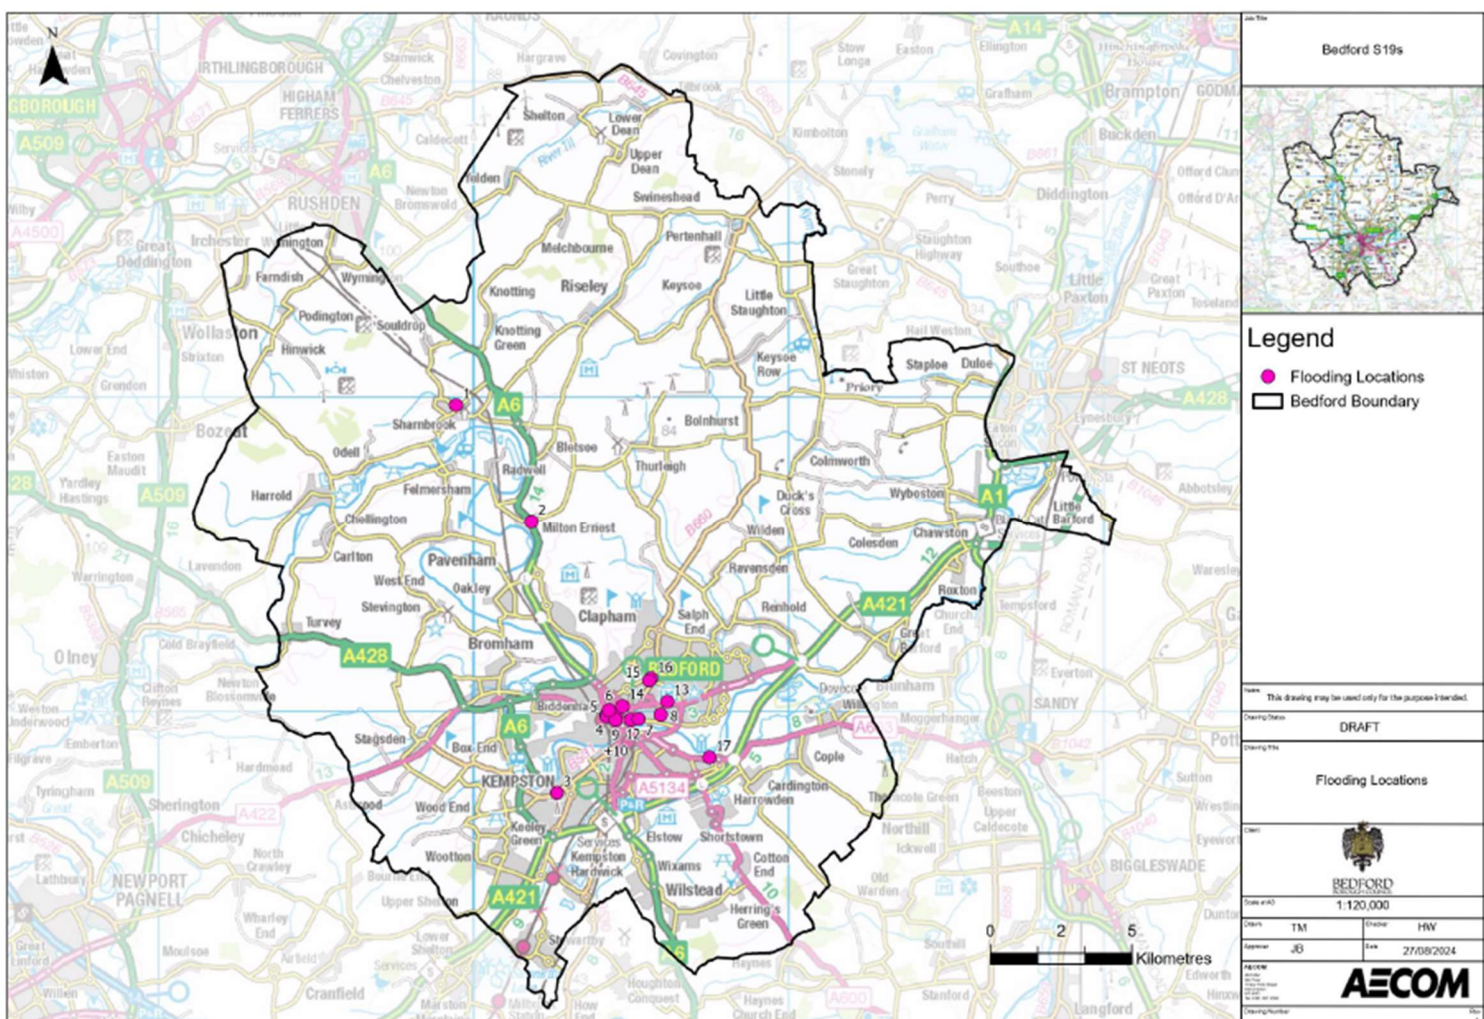
Figure 1.0 Flooding locations across the Borough October 2022

The Borough experienced flooding on the 20th of October 2022, with reports of internal property flooding at 17 locations. This only includes those reports that were provided to the Council. Figure 1.0 shows the extent of the flooding that occurred across the Borough.

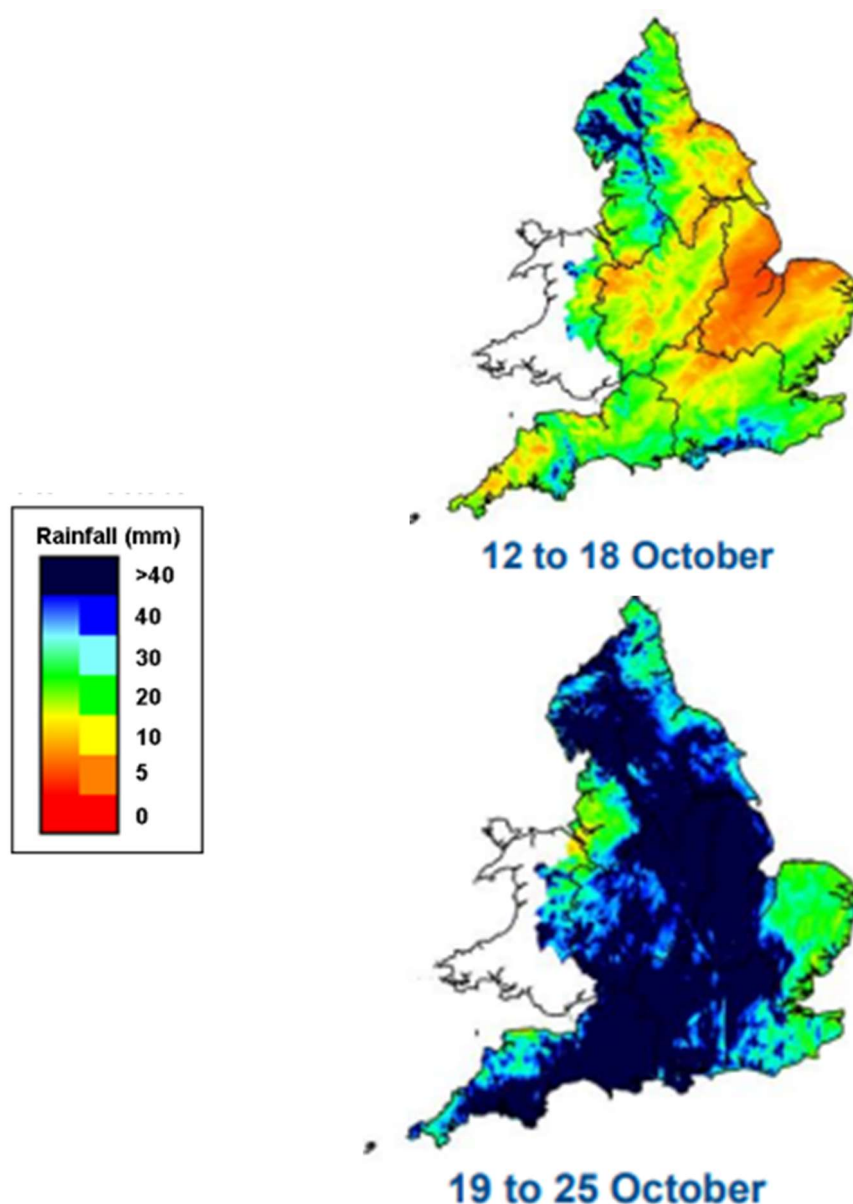
Figure 4.0 Weekly precipitation across England and Wales.
 Weekly Rainfall and Riverflow Reports for England.UKPP Radar Data

Following thunderstorms on the morning Thursday 20th October a total of 31.4mm of rainfall fell between 07:00 and 07:59 am and a total of. 44mm of rainfall over the 12-hour period. According to the Met Office Rain Gauge in Bedford. Average October rainfall between 1991-2020 is noted as 65.27 mm at the nearby Bedford Aerodrome. This suggests that approximately 50% of the total October average rainfall fell over the Borough in one hour, resulting in widespread surface water flooding.

Figure 4.0 Highlights the weekly precipitation across England and Wales and shows very clearly the rainfall that was received the week of the 20th of October 2022.
