Emergency Response and Recovery

Current Situation

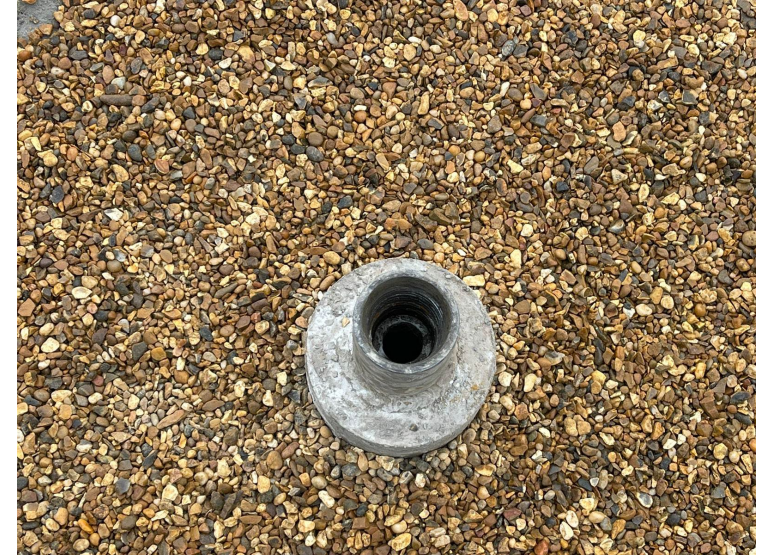
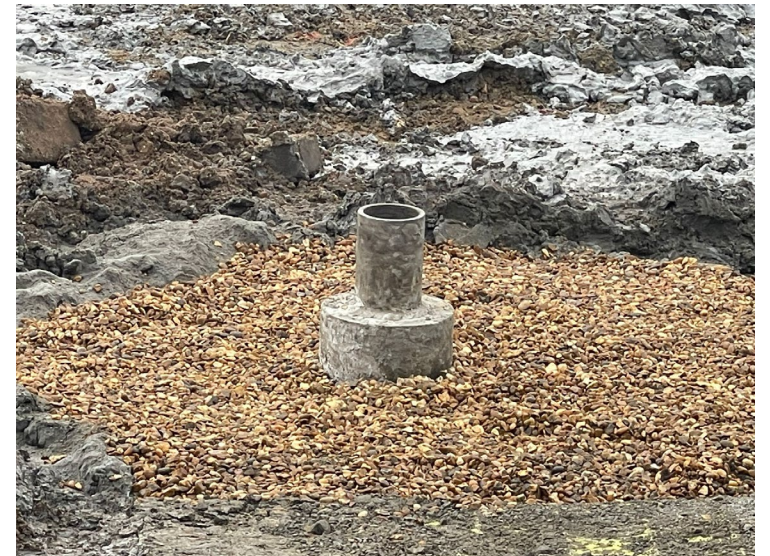
- Concrete sealing of the borehole has now been completed
- Cement has now cured
- Gas readings under continuous monitoring
- Continuous monitoring and checks

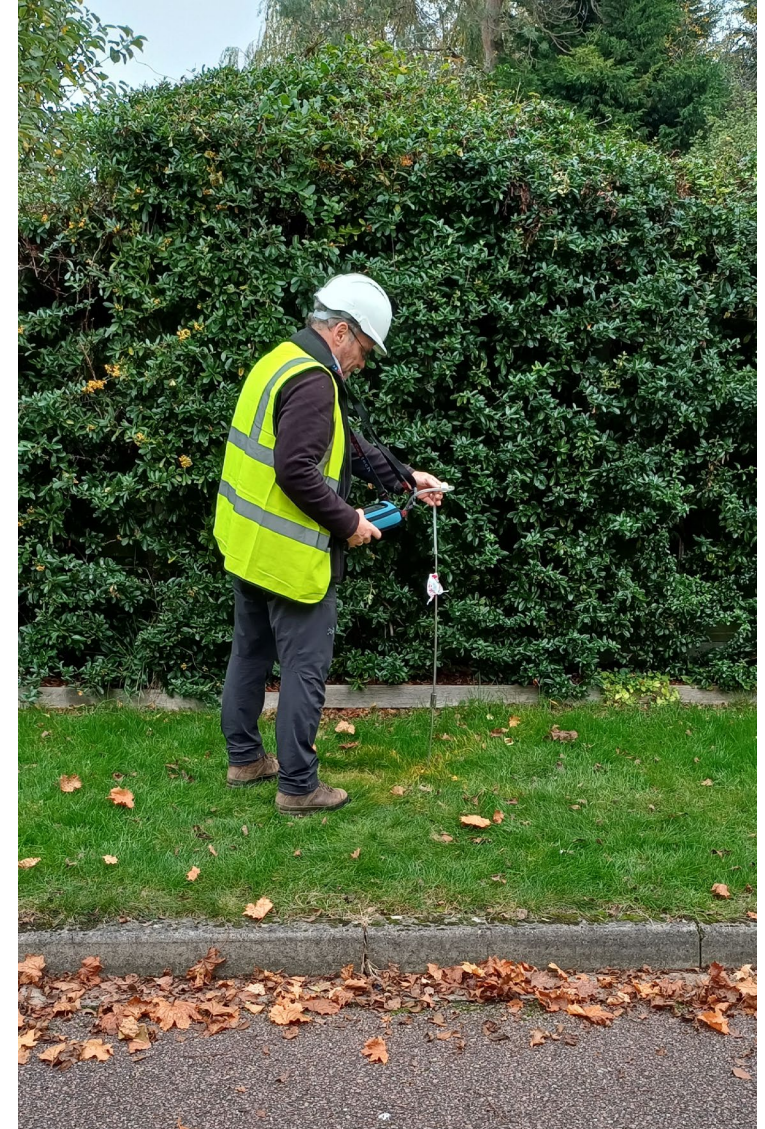
Our data (initial readings from 29th October)

- Observing fluctuations in readings over time
- Methane in soil 29th October
- To note:
 - Above baseline on Wagstaff Cl
 - Above baseline Glenrose Av (outside/edge of cordon)

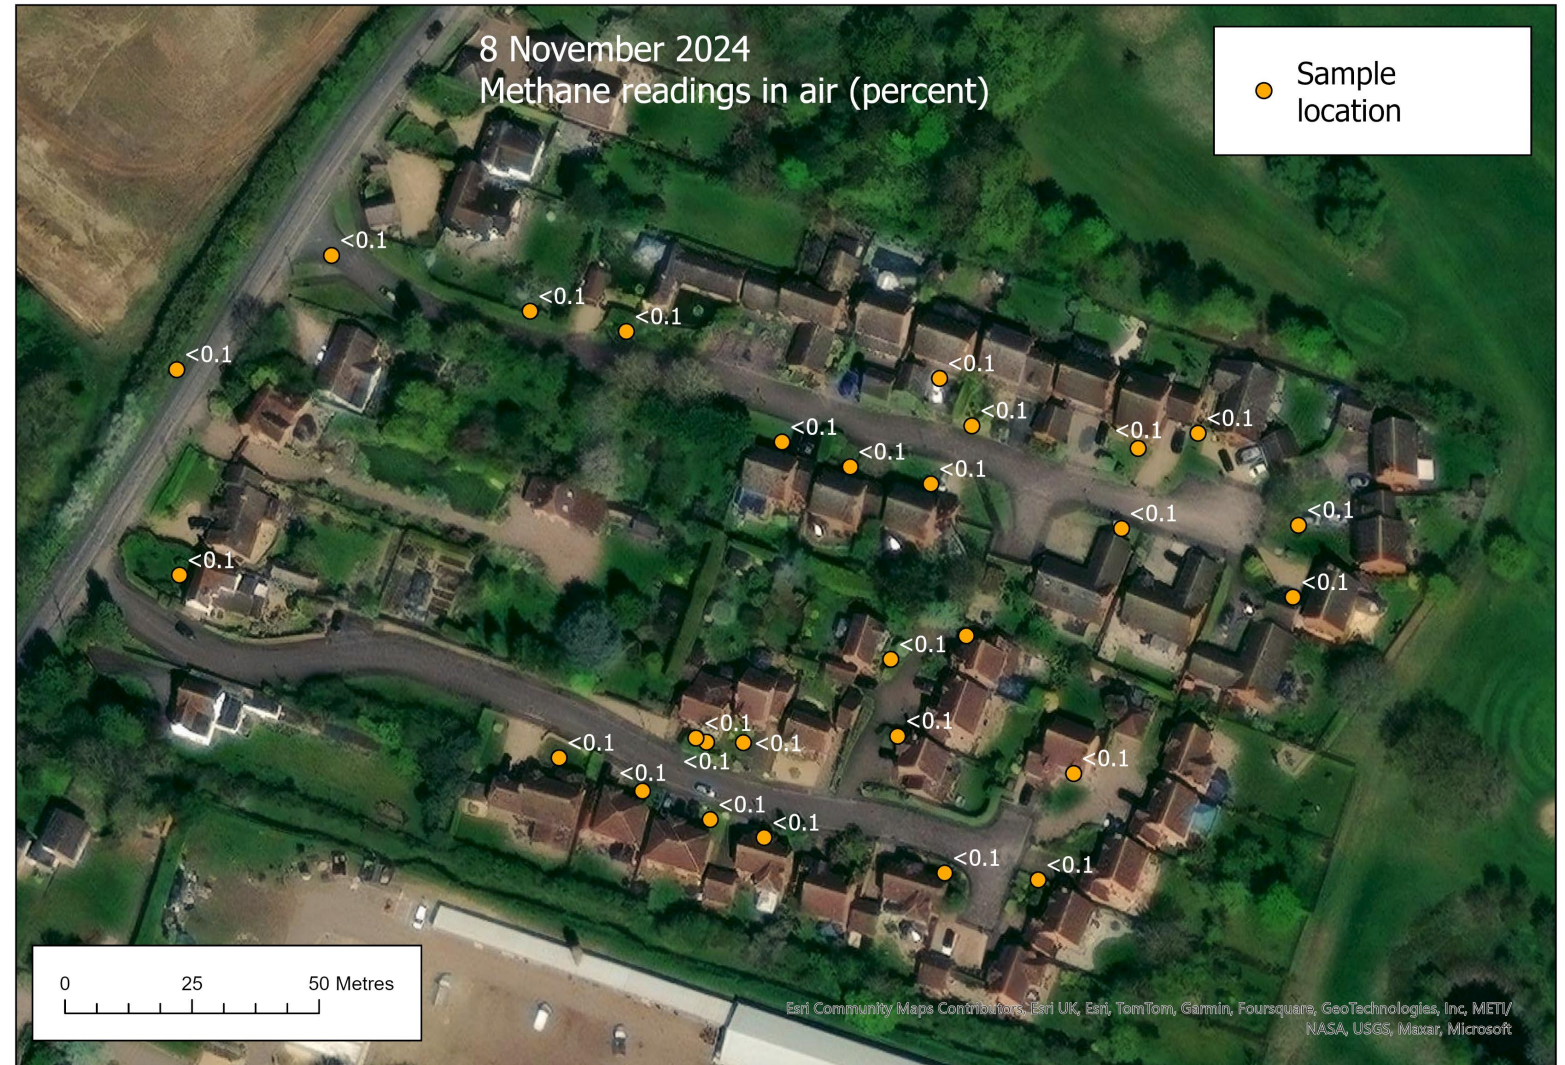
Latest data (BGS methane in air)

- Outside BGS
- In air measurements
- 8th November

- At present - our monitoring operations are recording low levels of gas, potentially below our current detection limits
- Latest BGS data supports the suggestion that gas flow from the borehole has been restricted, if not stemmed,
 - however ongoing work is seeking to understand the potential impact that changes in **environmental conditions** have on gas levels and flow (low pressure front/wind/rain and increased water pressure)
- The priority of BGS remains providing a robust set of data that the incident response coordinators can use in their decision-making, with our team remaining on site to continue monitoring work and collecting further readings.

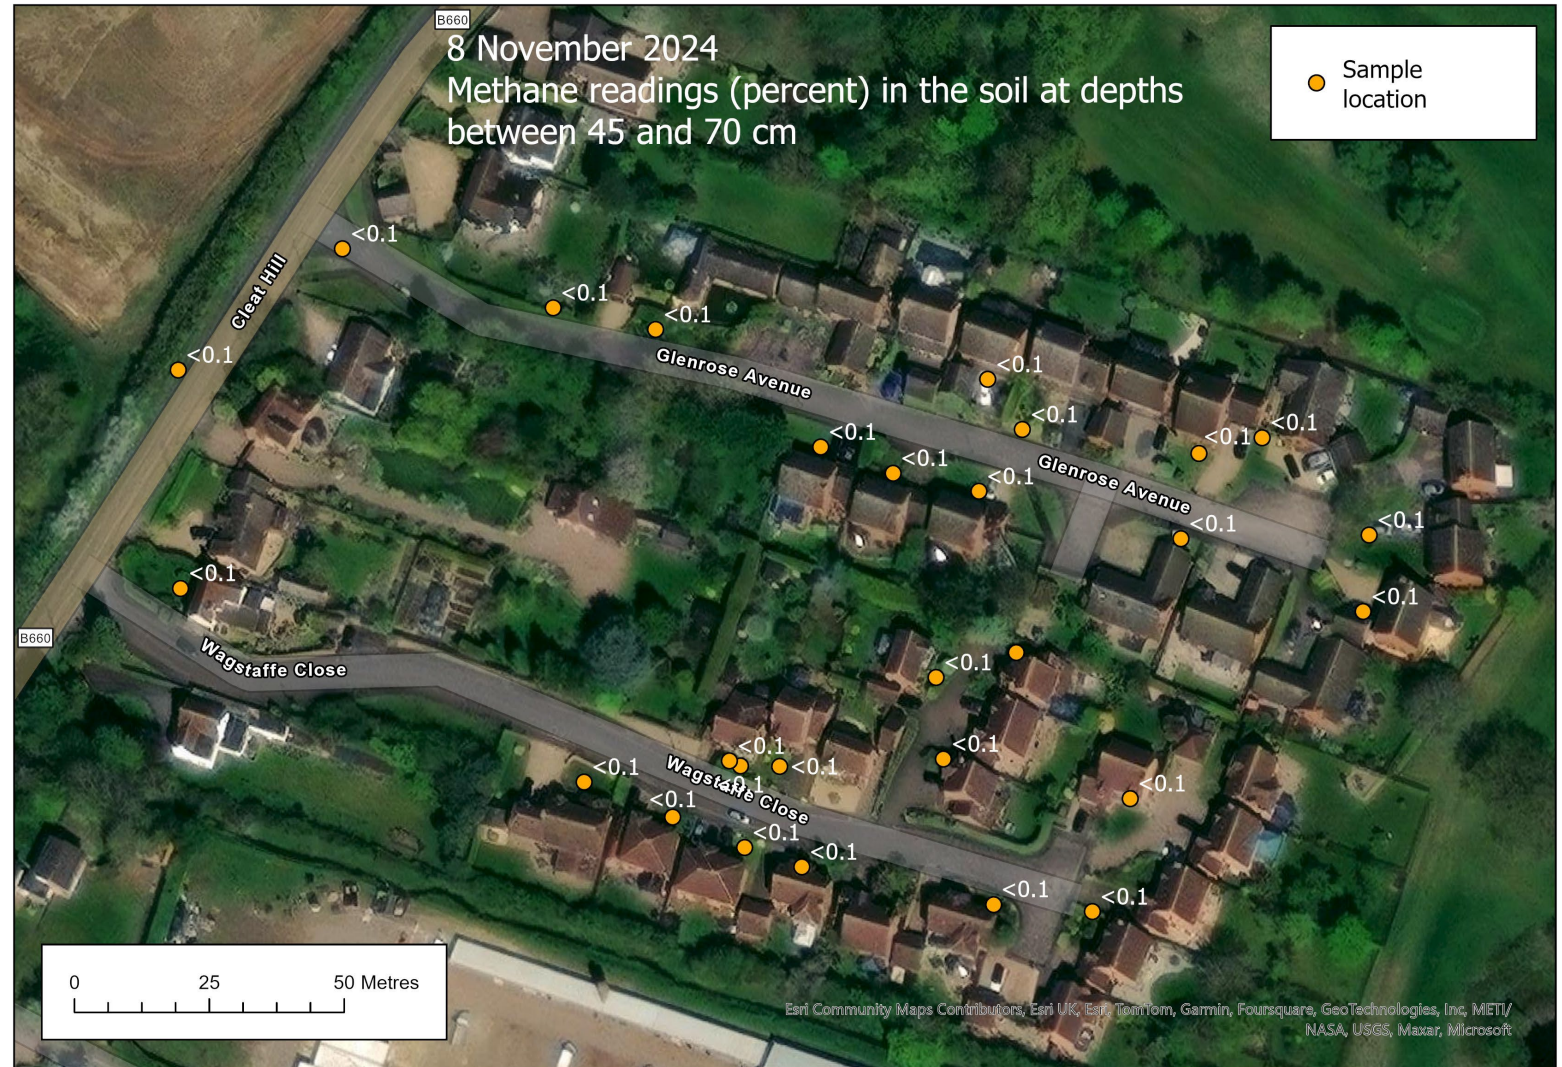
Latest data (BGS soil gas)

- Soil gas readings
- 8th November
